## THE MEDECO® DEADBOLT DESIGN: Disaster Waiting to Happen?

© 2007 Marc Weber Tobias

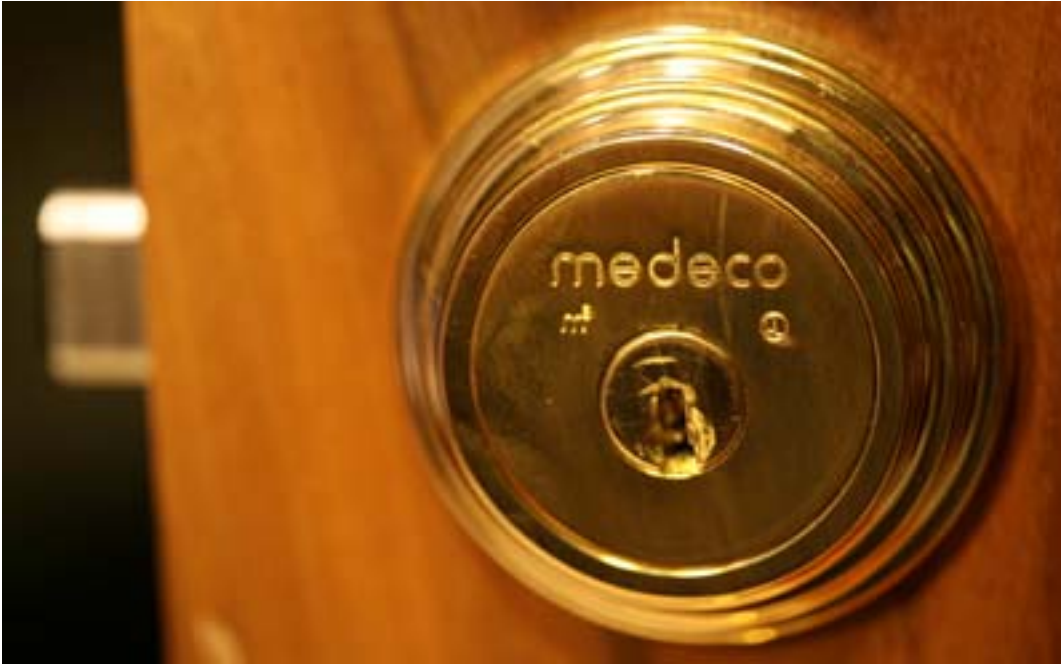
An example of a Medeco deadbolt cylinder that can be bypassed in seconds with simple tools by attacking the screws that retain the end-cap on the plug.

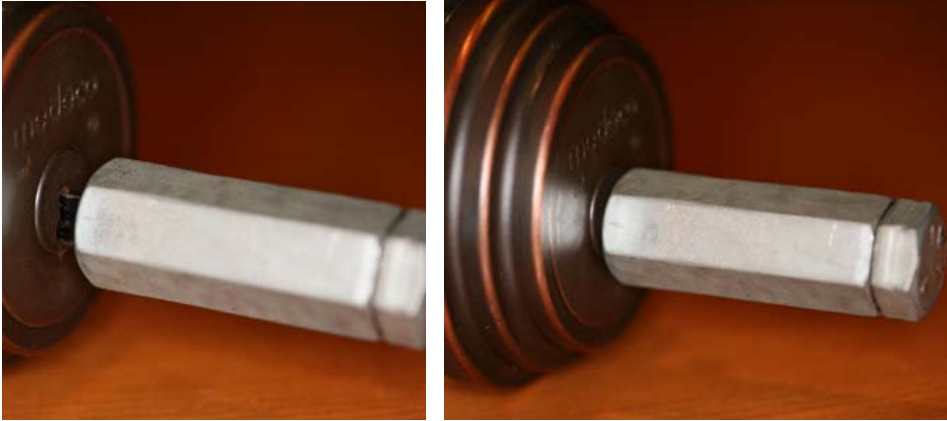
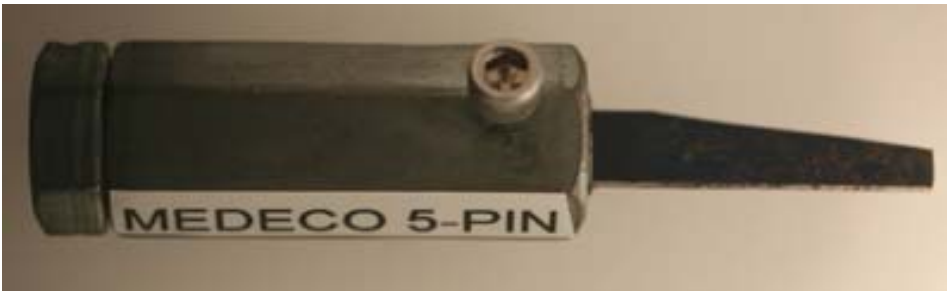
A special breaker tool was developed for five and six pin locks to apply extreme pressure on the tailpiece in order to shear the heads of the screws at the rear of the plug.

- Insert a specially designed breaker tool into the top of the keyway so that it abuts directly against the tailpiece;
- Apply sufficient force to shear the heads of the two retaining screws by striking it with a hammer;
- Insert a small tool that is shaped to mate with the end of the tailpiece;
- Push the tailpiece forward at least .120" so that it is no longer within the channel at the rear of the plug;
- Turn the tailpiece to retract the bolt.

This exploit can usually be accomplished in about thirty seconds with no apparent visible damage. Three strikes with a hammer are generally sufficient to shear the screws.

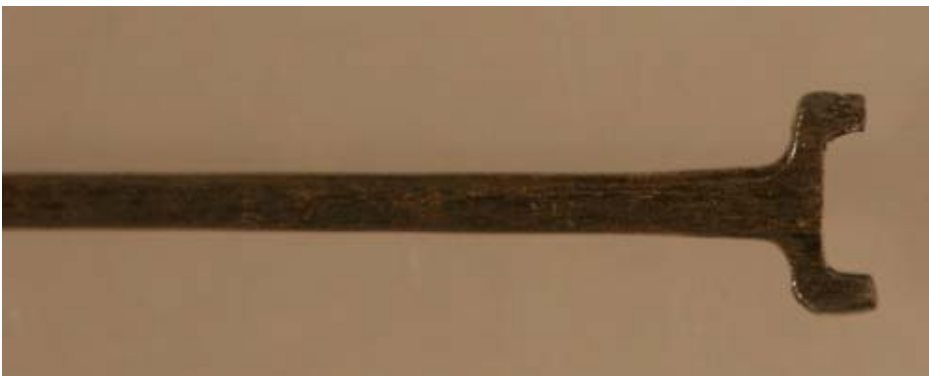
A simple screwdriver has been modified to manipulate the tailpiece.

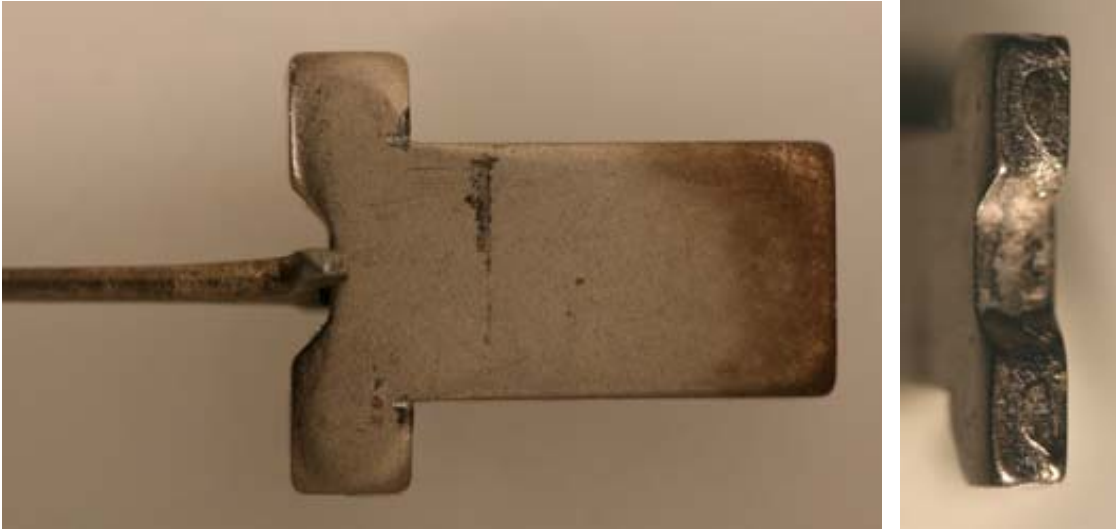
The manipulation tool is formed to precisely grab the edge of the tailpiece that abuts the end of the keyway.

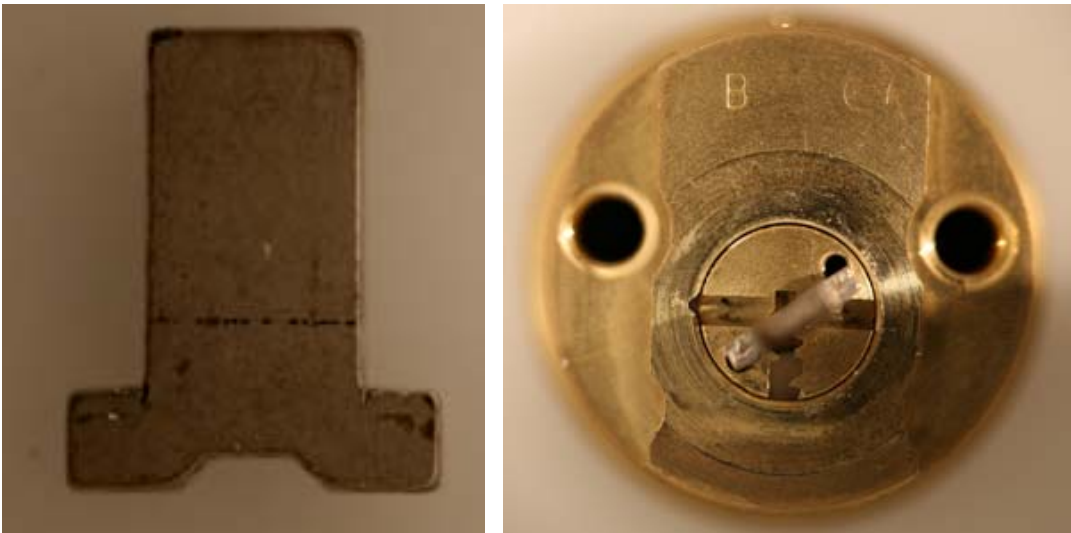
When the retaining screws are sheared the tailpiece is pushed forward approximately .120" in order to clear the horizontal channel within the plug. The tailpiece can then be rotated to control the deadbolt, as shown in the right photo.

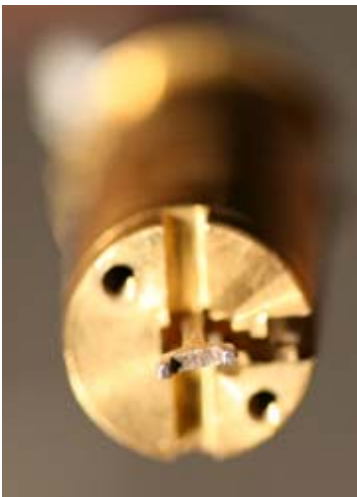
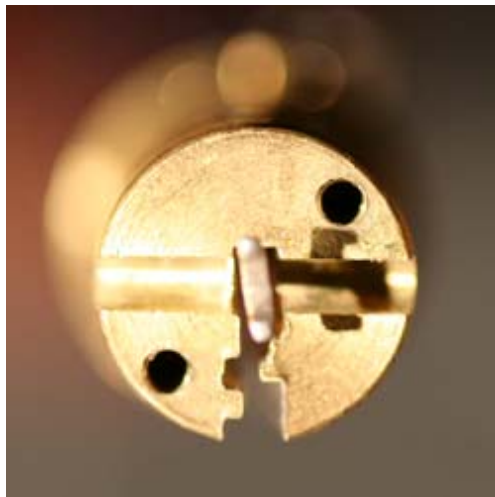
These photographs show the manipulator protruding through the end of the m3 keyway. The tailpiece can be easily turned with this tool.

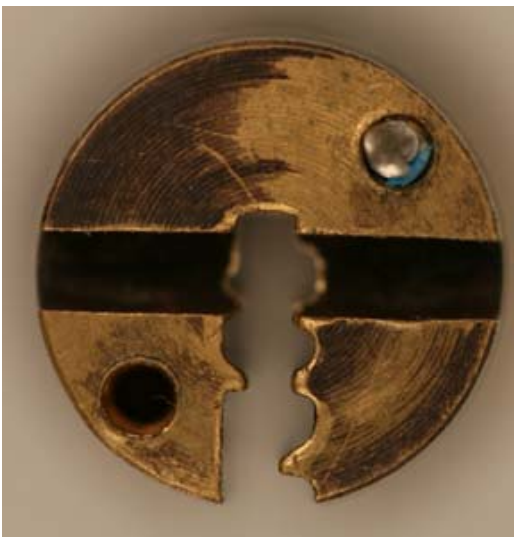
**This is a five-pin plug that has been compromised by shearing one of the retaining screws and driving the other from its bore.**

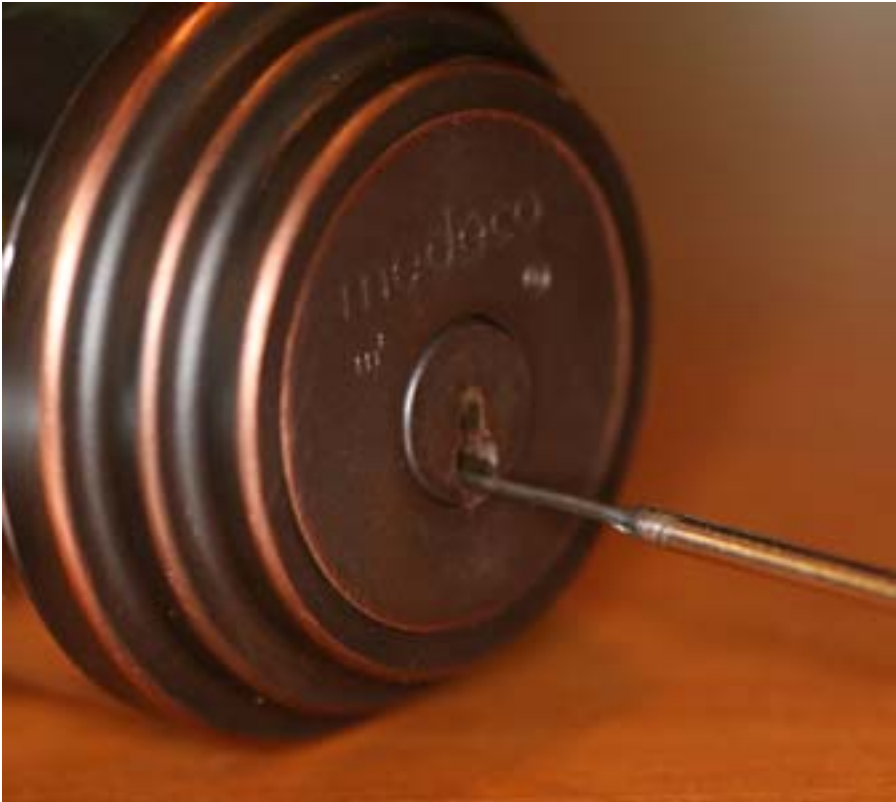
The manipulating tool is inserted to the end of the m3 keyway in order to access the tailpiece after the breaker tool has sheared the heads of the retaining screws.

We believe the second problem is the widened keyway in the m3. Although it appears that there is nominally only a difference in width of about .007" between the Biaxial and m3 it is sufficient to allow the insertion of our manipulation tool to successfully lock into and rotate the tailpiece. I am quite certain that this method of attack was never contemplated in the m3 design because it had apparently not been an issue with the Biaxial (which has employed essentially the same method of linking the plug to the tailpiece for many years).
